Document Number: 100127651

Title: Compatibility test between CEIA Walk-Through Metal Detectors and EasyRoller2

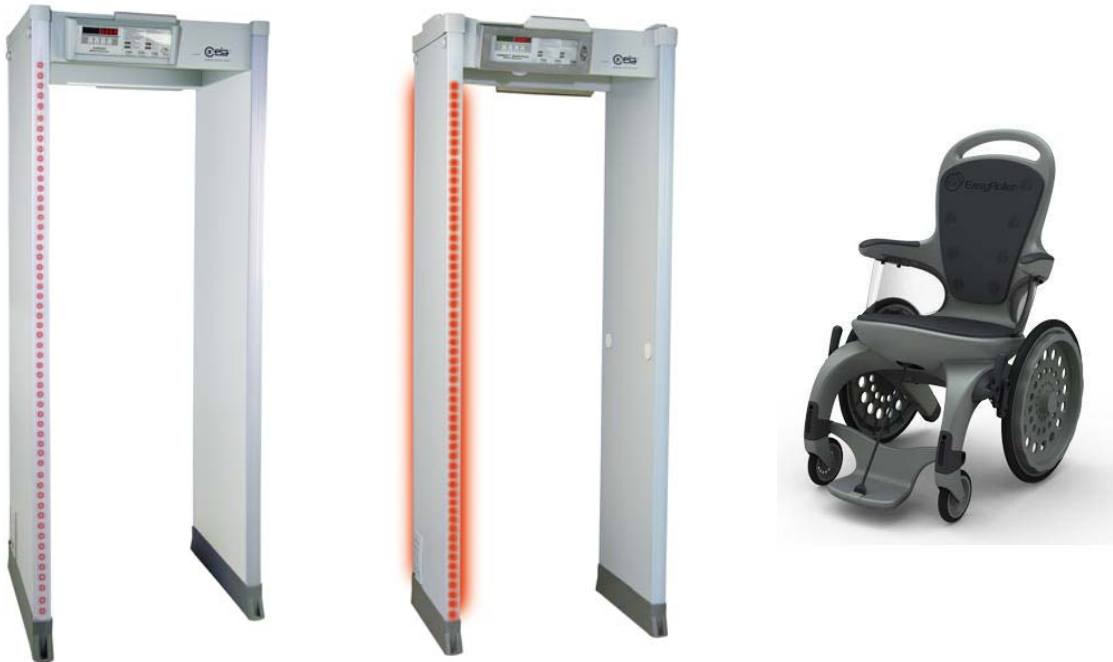
<p>The image shows two CEIA walk-through metal detectors standing side-by-side. The detector on the left is the CEIA 02PN20 model, and the one on the right is the CEIA SMD601 model. Both detectors have a vertical red LED strip on the left side. To the right of the detectors is a grey and black EasyRoller2 wheelchair, which is a specialized metal-free wheelchair.</p></div>

CEIA 02PN20 for airport application

CEIA SMD601 for high sensitivity application

EasyRoller2

<p>The two CEIA Metal Detectors has been set at the following level of sensitivity:</p> <p>02PN20 – European Airport Security Level SMD601 – NIJ0601.02 Standard – Small Object Size Class (high sensitivity application)</p> <p>The EasyRoller2 was passed through both Metal Detectors several times verifying that for each transit no signal was measured by the Metal Detector.</p>
Test results and final notes	<p>The result of the compatibility test between CEIA Walk-Through Metal Detectors and EasyRoller2 has been successful.</p> <p>It has been verified that no signal is generated in the Walk-Through Metal Detectors during the transit of the Easyroller2.</p> <p>This means that the Easyroller2 can be adopted to carry out security inspections of people who are not able to pass through the Walk-Through Metal Detector without the aid of a wheelchair.</p>
